YOUR ONESURVEY  
**HOME REPORT**

8 Craig Place  
Newton Mearns, Glasgow  
G77 6PA

# SINGLE SURVEY

# Single Survey

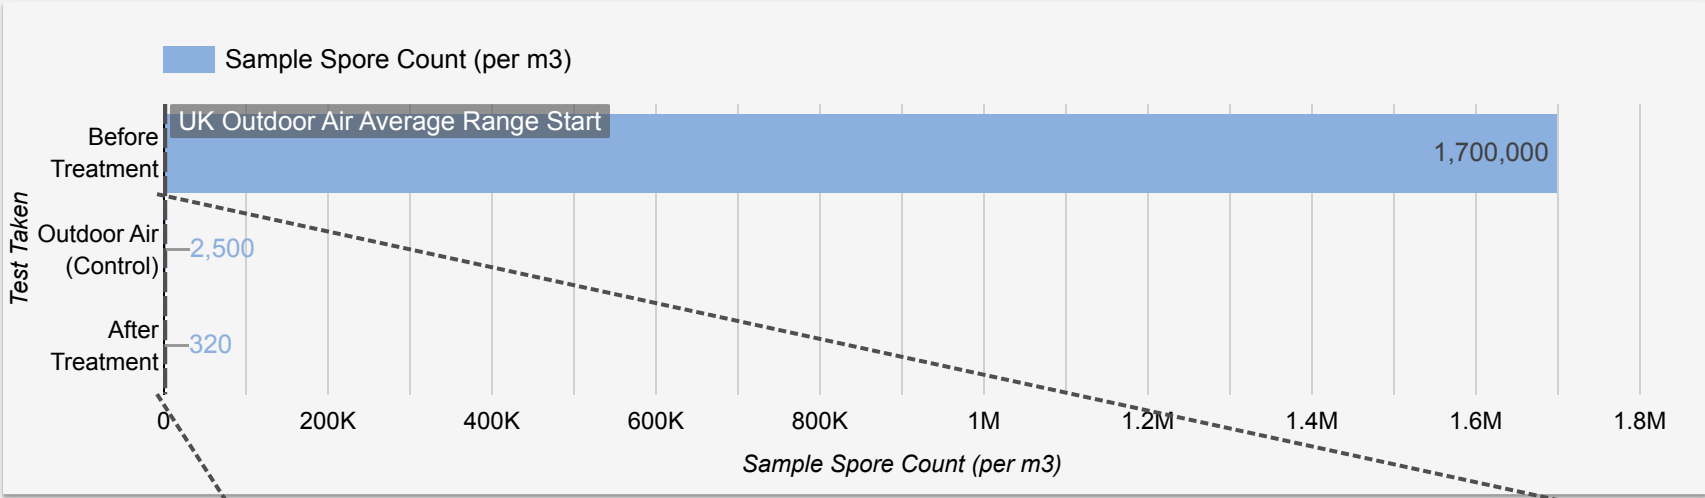
## Air Test Sample Mould Spores per m<sup>3</sup>

Spore Reduction\*  
**99.981%**

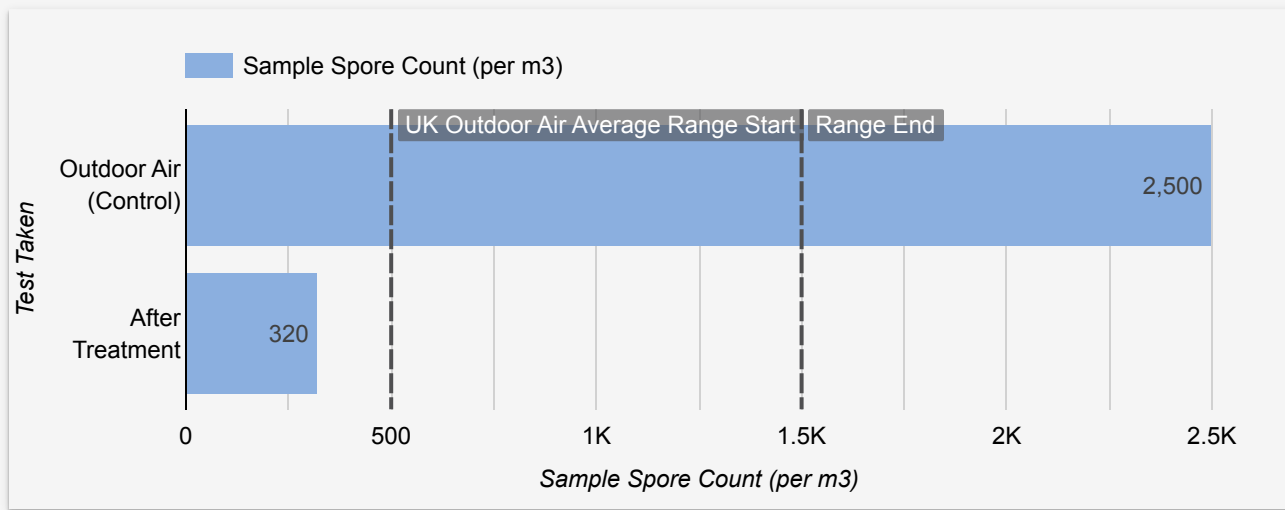
## After Treatment vs. Outdoor Air

*If our treatment is successful, we expect to see mould spore concentrations in the air to be very similar to outdoor air. Outdoor air can range very broadly based on season and sporelation cycles, but we've given a general range here based on what we expect in your area.*
