YOUR ONESURVEY  
**HOME REPORT**

8 Craig Place  
Newton Mearns, Glasgow  
G77 6PA

# SINGLE SURVEY

# Single Survey

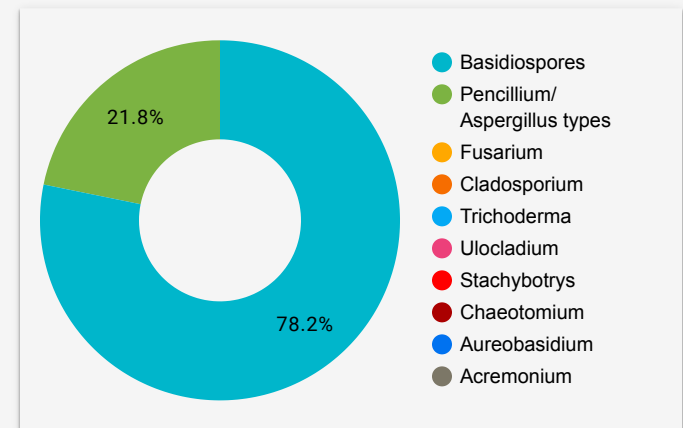
### Outdoor Test Breakdown of Mould Genus

*Another sign of a successful treatment is that the indoor variants should closely approximate outdoor mould variants. Any anomalies between the two can indicate a potential indoor growth. Although moulds like Stachybotrys and Chaetomium can grow outdoors, our preference is to not see any after our treatment is completed.*
