HOME REPORT

41 HAZELWOOD AVENUE
NEWTON MEARNS
GLASGOW
G77 5QT

Energy Performance Certificate (EPC)

41 HAZELWOOD AVENUE, NEWTON MEARN, GLASGOW, G77 5QT

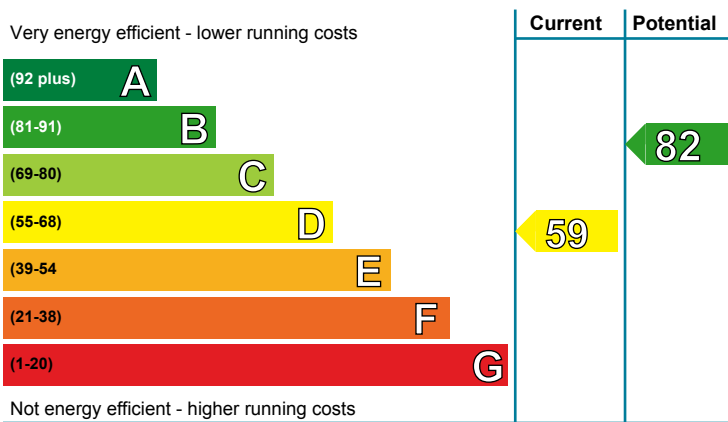
Energy Efficiency Rating

This graph shows the current efficiency of your home, taking into account both energy efficiency and fuel costs. The higher this rating, the lower your fuel bills are likely to be.

Your current rating is **band D (59)**. The average rating for EPCs in Scotland is **band D (61)**.

The potential rating shows the effect of undertaking all of the improvement measures listed within your recommendations report.
