HOME REPORT

21 Waulkmill Avenue
Barrhead, Glasgow
G78 1DD

Single Survey

Surveyor Reference	PD/9409
Customer	Mr. Gursajan Singh
Selling address	21 Waulkmill Avenue Barrhead, Glasgow G78 1DD
Date of Re-inspection	20/01/2026
Date of Original Inspection	26/08/2025
Prepared by	Ross Carpenter, MRICS Bsc (hons) Paisley - Allied Surveyors Scotland Ltd

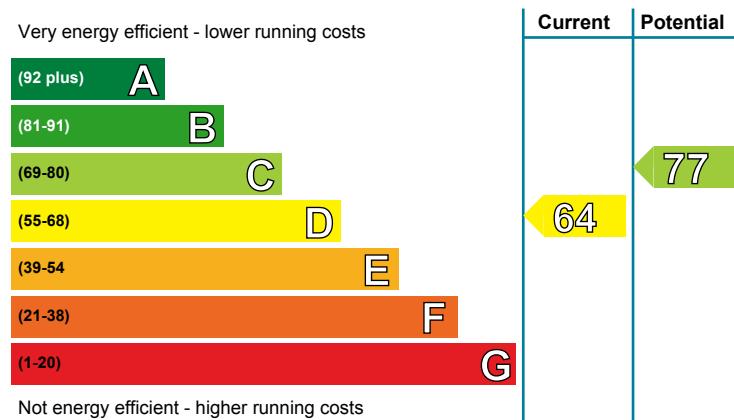
Energy Efficiency Rating

This graph shows the current efficiency of your home, taking into account both energy efficiency and fuel costs. The higher this rating, the lower your fuel bills are likely to be.

Your current rating is **band D (64)**. The average rating for EPCs in Scotland is **band D (61)**.

The potential rating shows the effect of undertaking all of the improvement measures listed within your recommendations report.

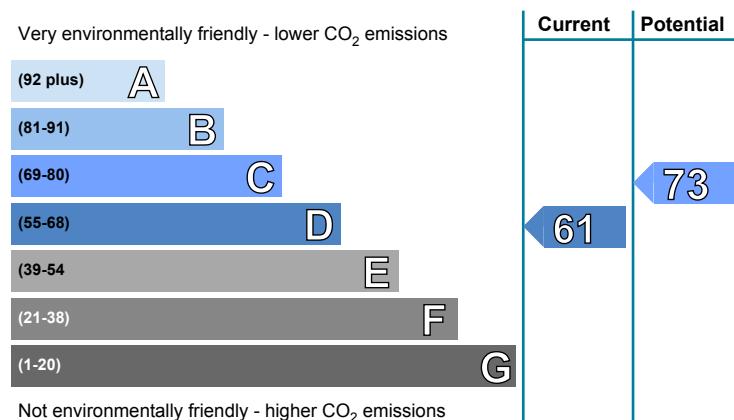
Environmental Impact (CO₂) Rating

This graph shows the effect of your home on the environment in terms of carbon dioxide (CO₂) emissions. The higher the rating, the less impact it has on the environment.
