YOUR ONESURVEY
HOME REPORT

143 Kilpatrick Gardens
Clarkston
Glasgow
G76 7RN

SINGLE SURVEY

Single Survey

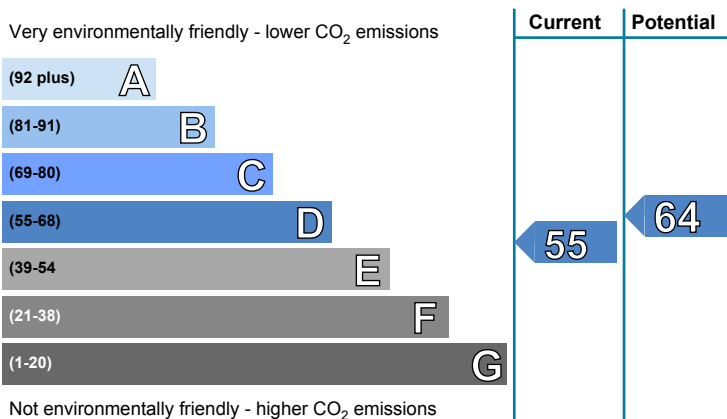
Environmental Impact (CO₂) Rating

This graph shows the effect of your home on the environment in terms of carbon dioxide (CO₂) emissions. The higher the rating, the less impact it has on the environment.
